Back to the Future

Reverse-designing a shelter for extreme weather in Antarctica

Araújo, Gonçalo¹; Roaf, Sue²; Correia Guedes, Manuel³; Leitão, António¹; Pinelo, João⁴

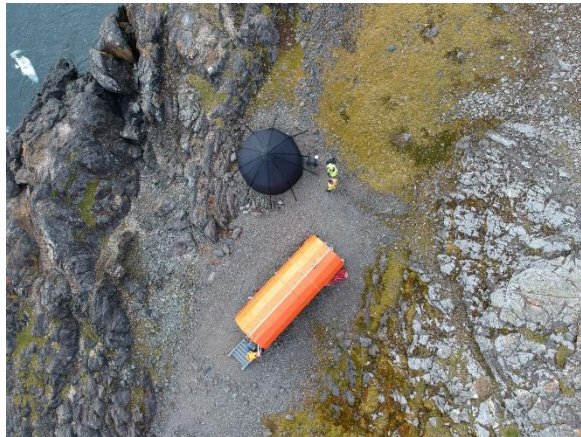
Four expeditions to King George Island resulted in the development of a high-performance shelter at Collins glacier (Fig. 1), which can be easily built in a day and house up to four field workers comfortably while resisting extreme winds and cold temperatures throughout the year. A prototype inspired on a

Fig. 1 - Polar lodge drone view at Collins glacier.

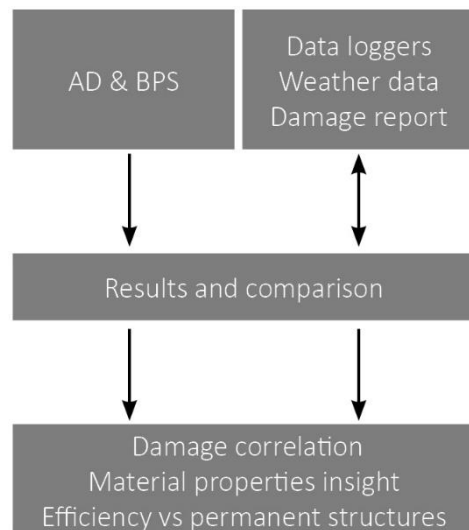
To achieve the proposed goals, the workflow presented in Fig. 2 starts by analyzing the data collected from an expedition to Antarctica, particularly, regarding the damage suffered by the envelope shelter, and moves on to the use of an algorithmic design and analysis tool to model the shelter and simulate its behaviour [12]. One of the advantages of this tool is its ability to coordinate different analyses, as well as integrate them with optimization algorithms within the same platform [13].

Fig. 2 – Research workflow.

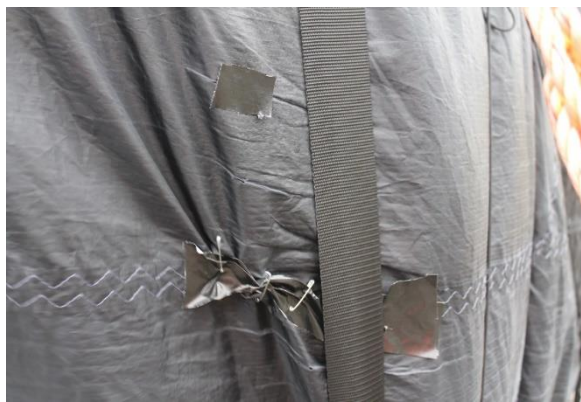
damage, which showed that the outdoor window was partially open over winter, and there were some shreds in the Dyneema layer (Fig.3). These were mapped and incorporated in a model for further correlation with wind speed data. The hypothesis is that the wind speed was sufficient to create the Von Kármán Vortex Street pattern responsible for generating fabric vibrations, which ripped in its seams [14]. Through the CFD simulation, it is possible to check if high speeds are occurring in the shredded areas, indicating the creation of these patterns and the necessity of applying a different method to attach the envelope layer. Following the damage survey, data loggers were implemented outdoors and indoors during the whole mission period, collecting temperature, relative humidity, and illuminance.

Fig. 3 - Temporary mend of the envelope shreds with tape and safety pins

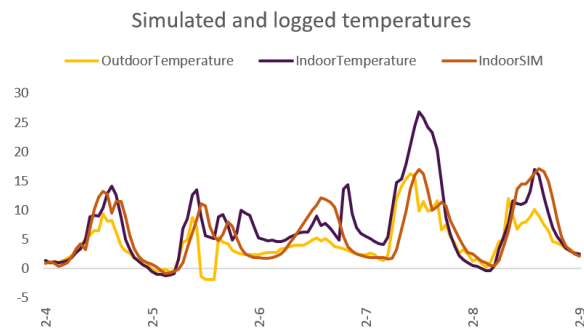
Upon arrival at Collins glacier, loggers were set from February 2nd to 9th, and the team occupied it for repairs and surveys from the 5th in the afternoon to the 8th in the morning, which meant that the door had to be open for most of the repairs, and the gas heater was used in the early night. During this period, simulation results for the shelter's operative indoor temperatures show the biggest discrepancies, since occupancy schedules were turned off. While considering this period, it is visible an average deviation between logged temperatures in the field and those simulated of ± 3 degrees $^{\circ}\text{C}$, and with maximum values reaching a standard deviation of 10°C . However, if we exclude the occupied period, this lowers considerably to an average of $\pm 1^{\circ}\text{C}$ and a standard of 5.5°C (Fig.7).

Fig. 7 – Indoor and outdoor operative temperatures logged in the field and simulated indoor temperature

Results show good thermal heat storage during the day regarding the tent performance, with values reaching over 25°C with a small gas heater turned on, and 15°C while unoccupied. Nevertheless, minimum temperatures of $\approx 0^{\circ}\text{C}$, similar to outdoor temperatures, were registered during unoccupied nights around 1:00 AM (Fig.8). Additionally, the high humidity values and the damage registered are an indication that the shelter is not doing well regarding infiltrations, suggesting that additional steps are needed to address this issue. Finally, these results indicate an accurate simulation that allows estimating the tent performance throughout the year, with an acceptable level of confidence.
